DEPARTMENT OF TRANSPORTATION

Quality Assurance and Source Inspection

Contract #: 04-0120F4Cty: SF/ALA Rte: 80 PM: 13.2/13.9File #: 69.28**WELDING INSPECTION REPORT****Resident Engineer:**Siegenthaler, Peter**Address:** 333 Burma Road**City:** Oakland, CA 94607**Report No:** WIR-018472**Date Inspected:** 29-Nov-2010**Project Name:** SAS Superstructure**OSM Arrival Time:** 645**Prime Contractor:** American Bridge/Fluor Enterprises, a JV**OSM Departure Time:** 1845**Contractor:** Zhenhua Port Machinery Company, Ltd (ZPMC), Changxing Island **Location:** Shanghai, China**CWI Name:** Liu Hua Jie.**CWI Present:** Yes No**Inspected CWI report:** Yes No N/A**Rod Oven in Use:** Yes No N/A**Electrode to specification:** Yes No N/A**Weld Procedures Followed:** Yes No N/A**Qualified Welders:** Yes No N/A**Verified Joint Fit-up:** Yes No N/A**Approved Drawings:** Yes No N/A**Approved WPS:** Yes No N/A**Delayed / Cancelled:** Yes No N/A**Bridge No:** 34-0006**Component:** Orthotropic Box Girder(OBG)**Summary of Items Observed:**

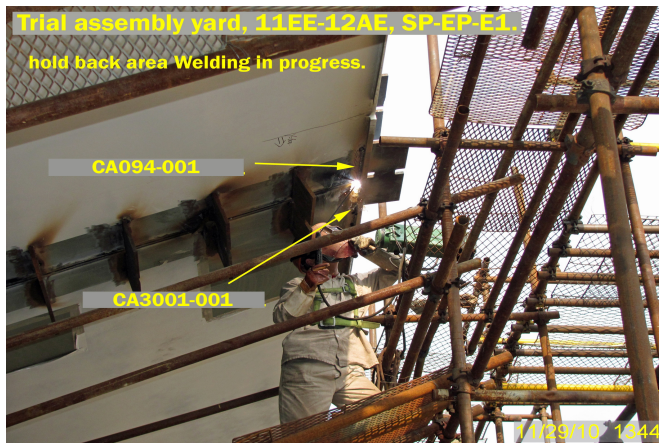
SMAW welding of weld joint CA094-001, CA3001-001; located at Trial assembly yard. Welder is identified as 044515; ZPMC Quality Control Inspector (QC) is identified as Liu Hua Jie. The welding variables recorded by Quality Control Inspector (QC) appeared to comply with the Applicable WPS: WPS-B-P-2214-TC-U4B-FCM-1. The attached photographs provide additional detail.
